Parasailing Safety

Special Investigation Report

NTSB/SIR-14/02
PB2014-106341

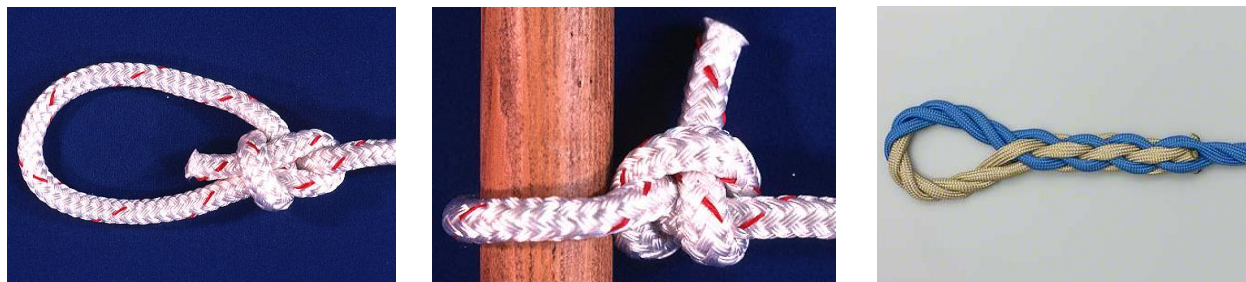
The riser end of the towline displayed stretching and a distinctive reduction in diameter when compared to the winch end. Further, investigators found three areas of localized compression within 30 inches of the riser end that were consistent with the towline having been knotted in those spots at some time. Generally, parasailing operators use a bowline knot (left, figure 3) to attach the towline to the riser, and this master had done so, too. However, he had also tied several hitch knots (center, figure 3) in the towline.

Figure 3. The photos illustrate three ways to fasten a rope: A bowline knot (the most commonly used knot in parasailing operations); a hitch knot; and a spliced eye. (Bowline and hitch knot photos by James Aber; spliced eye photo by Grog, LLC.)

The testing revealed that the towline itself was stronger than advertised, but the introduction of a bowline knot drastically reduced the towline's strength, by more than half. Moreover, the addition of hitch knots further weakened the towline's strength, to less than 40 percent of the advertised strength. However, using only spliced eyes had no adverse effect on the towline's strength.

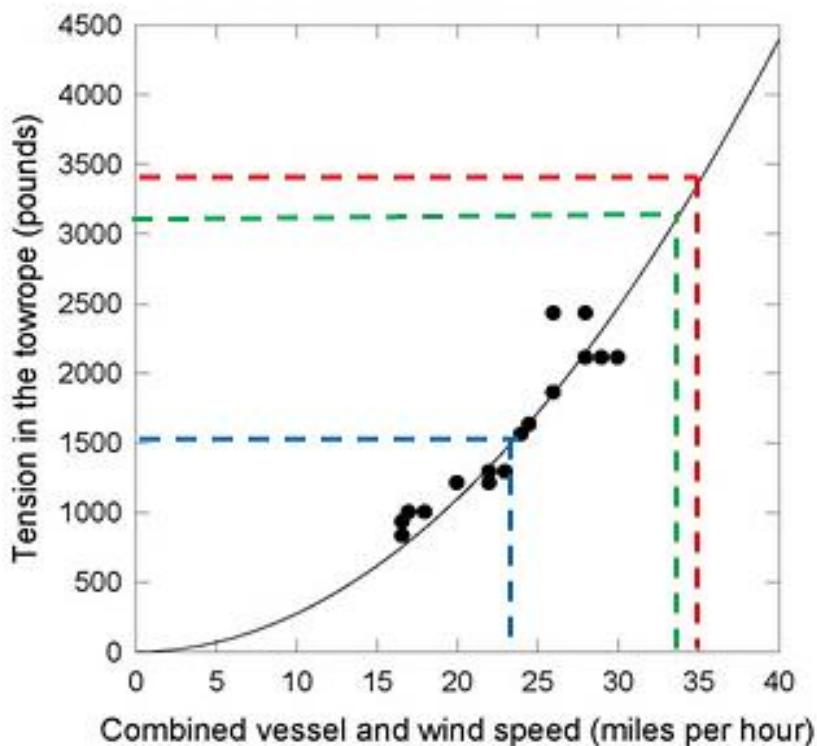
Figure 4. Towline tension force at combined vessel and wind speeds.

As illustrated in the above figure 4, the data points and the curve axes start at zero and extend beyond the data points. The horizontal red dashed line represents the accident towline average failure load of 3,415 pounds (from the laboratory testing of the towline from the *Tied High*), and crosses the curve in the vicinity of a combined vessel and wind speed of 35 mph, as indicated by the vertical red dashed line. Similarly, the horizontal blue dashed line represents the working load of 1,520 pounds specified in the manufacturer’s literature for that towline, and indicates that a combined vessel and wind speed of about 23 mph could exceed that working load. (See section “3.2 Winch Testing and Examination; Vessel: *Tied High*” for details on the green dashed line).

When compared with the field test results at similar combined wind speeds, investigators noted that the variation exceeded the 10 percent change specified in the manufacturer's literature and would constitute a hazardous shock load that would void the normal working load recommendation. In summary, investigators concluded that because of cyclic loading, exposure to environmental elements, the presence of knots, overloading, or a combination of these factors, towlines have repeatedly failed at levels significantly below their rated strength. (See page 34 for a safety alert about this issue.)

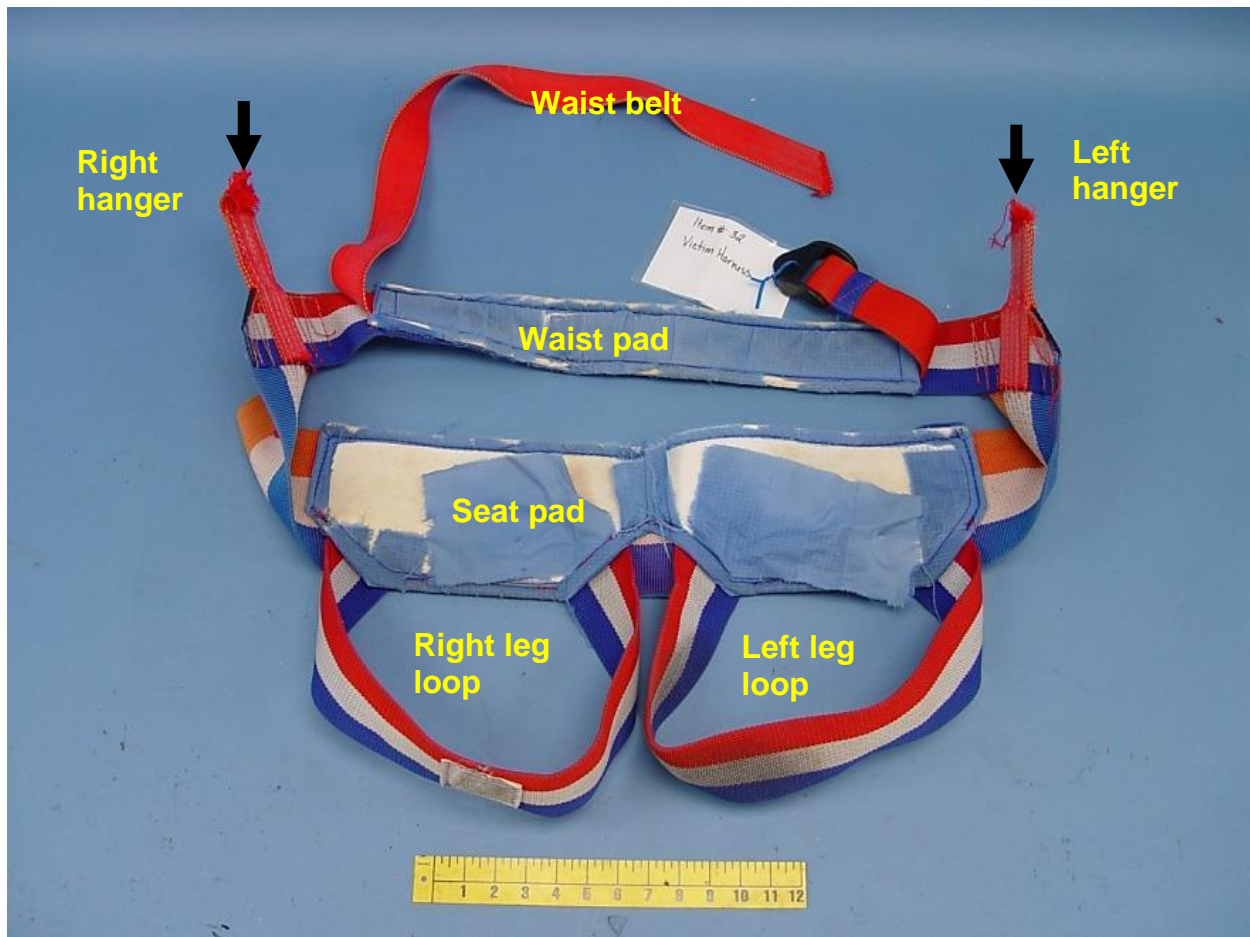
examined the fractured harness that she had been wearing (figure 7). The fractured ends of the red hangers displayed raveled filaments adjacent to the fractures. The tips of the filaments were relatively flat and oriented on a slant plane, or were split and showing white discoloration, all features consistent with overload separation. In addition, much of the blue covering on the seat pad was worn out from extended use and revealed the underlying white padding. Worn areas on the waist pad also exposed white padding. Investigators removed the red waist belt for tensile testing (see section “3.4 Tensile Testing of Harness Waist Belts”).

Figure 7. Fractured harness, worn by the victim. The black arrows illustrate the fractured ends of the hangers.

Investigators learned that the parasailing operator had purchased a bag of harnesses from another operator who was going out of business. The history of the harnesses (frequency of use, extent of exposure to saltwater and sun, etc.) was unknown. Investigators could not determine the precise age of the accident harness, but by researching and analyzing images of the hanger webbing and stitching, they concluded that the harness had likely been made in England in the late 1990s or early 2000s.

Comparison of the two harnesses revealed that the hangers on the fractured harness consisted of a single piece of webbing that extended from the flight bar attachment to the seat/waist webbing junction. The hangers on the intact harness consisted of two pieces of webbing that were sewn together and extended from the flight bar attachment through the seat/waist webbing junction, under the seat, through the other seat/waist webbing junction and to the other flight bar attachment. The intact harness that the victim's husband had been wearing had a more robust original design and was also less degraded from extended use.

Examination of the fractured ends of the black waist belt and the black webbing samples from the intact harness revealed raveling and filaments displaying globular tips consistent with a high energy overload separation. The significant strength reduction of the red waist belt from the fractured harness explains the separation features noted earlier. The red waist belt was also subjected to testing that revealed that the polypropylene in the belt was degraded from sun exposure.

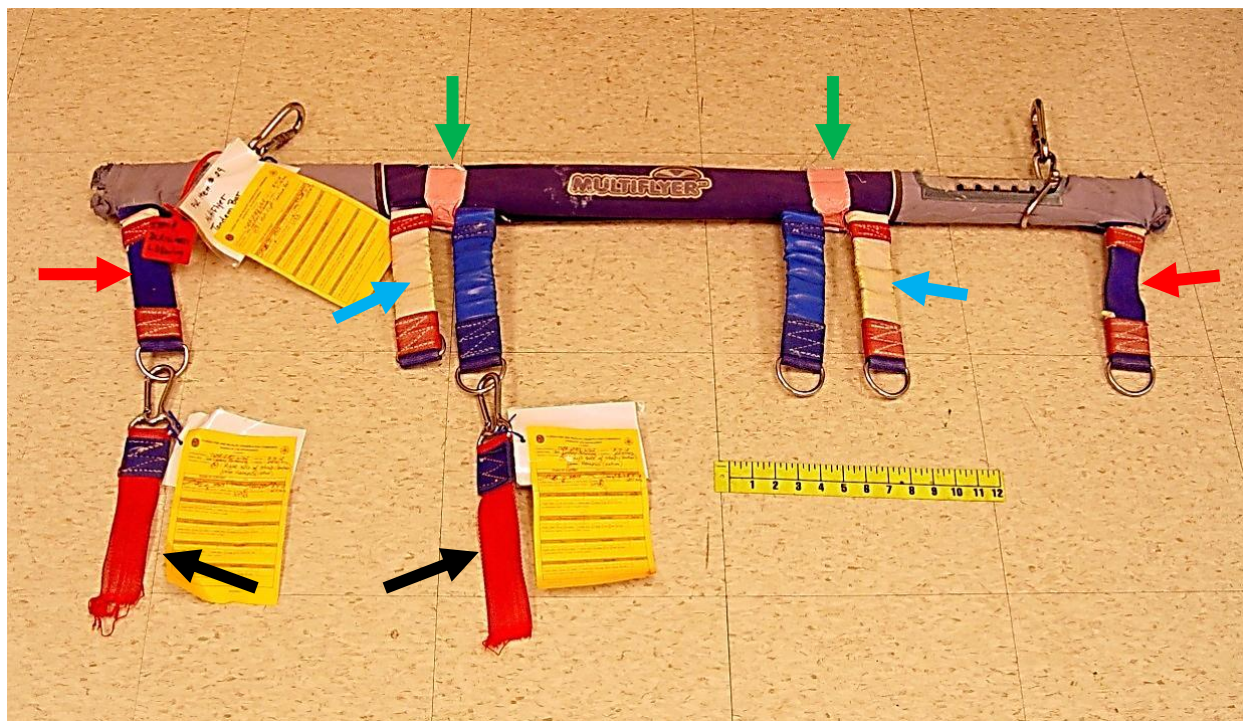
Investigators also examined the flight bar from which the harness detached (figure 8). Torn portions of the harness’s left and right hangers were still attached to the flight bar.

Figure 8. Accident flight bar.

Examination of the flight bar revealed torn and missing padding at the outer ends, and most of a protective cover missing from the outer straps (indicated by red arrows). What remained on the outer straps was the same cream color as the cover on the next inboard strap, indicated by the blue arrows. When investigators turned the edges of these covers, it was revealed that the inboard straps were originally red but had faded due to extended use and sun exposure. The green arrows indicate a portion of pink-colored duct tape that had originally obscured most of a warning label on the opposite side of the flight bar, but now only the adhesive remained.¹⁸ On the warning label's lower edge, "www.customchutes.com" was displayed.

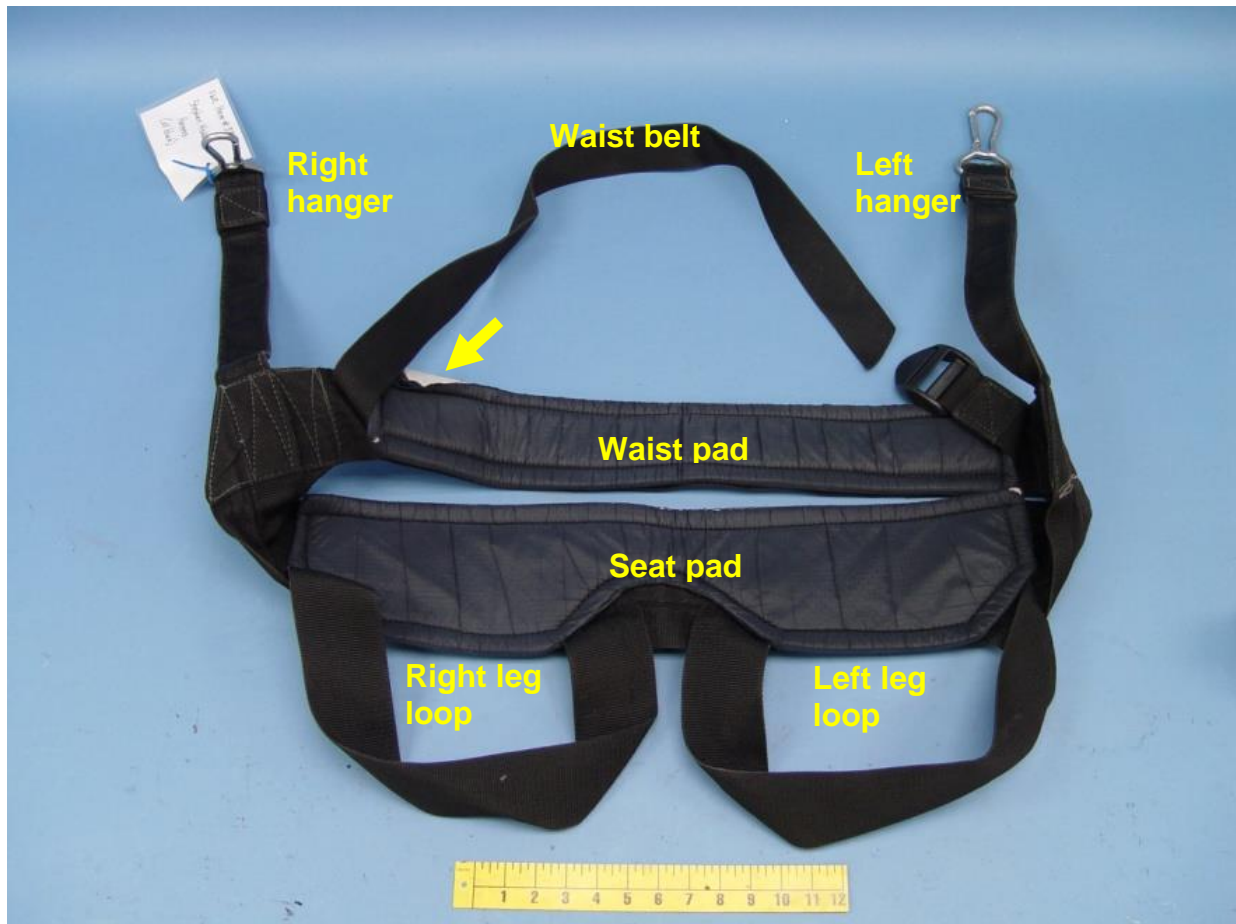
Figure 9. Intact harness, worn by the victim's husband.

The husband's harness, like the flight bar, was manufactured by Custom Chutes. This harness had only a small worn area where the white padding was exposed, indicated by the yellow arrow in the image. The waist belt from this harness was also removed for tensile testing (see section "3.4 Tensile Testing of Harness Waist Belts").

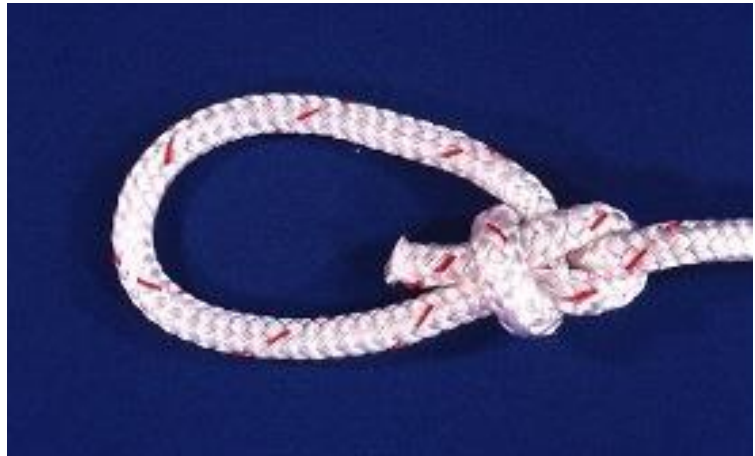
Towline failure is the leading cause of injury and death in parasailing accidents.¹ The NTSB recently studied several parasailing accidents and verified that the knot most commonly used by parasailing operators to fasten their towlines is a bowline knot. In subsequent laboratory testing, the NTSB confirmed that this knot (and any knot in general) can reduce towline strength by as much as 70 percent, even on brand-new, otherwise-strong ropes.²

A bowline knot, the knot most commonly used by parasailing operators in their towlines. This type of knot can weaken a brand-new rope by as much as 70 percent.

- Frequently and carefully inspect your ropes to ensure that they are in good overall condition with no sign of external abrasion or other damage, and that they are suitable for the intended operation.

- Store your ropes in a clean and dry location out of direct sunlight.
- Trim back the working ends of the ropes as needed, and replace your ropes frequently. For more specifics, consult a recognized source of information such as the Cordage Institute on the selection, care, and disposition of ropes. In addition, refer to the standards for parasailing equipment, currently being developed by ASTM International.
